Figure 5 (FER-85), Locations of active faults based on trench data, and interpretation of aerial photographs, and field checking.

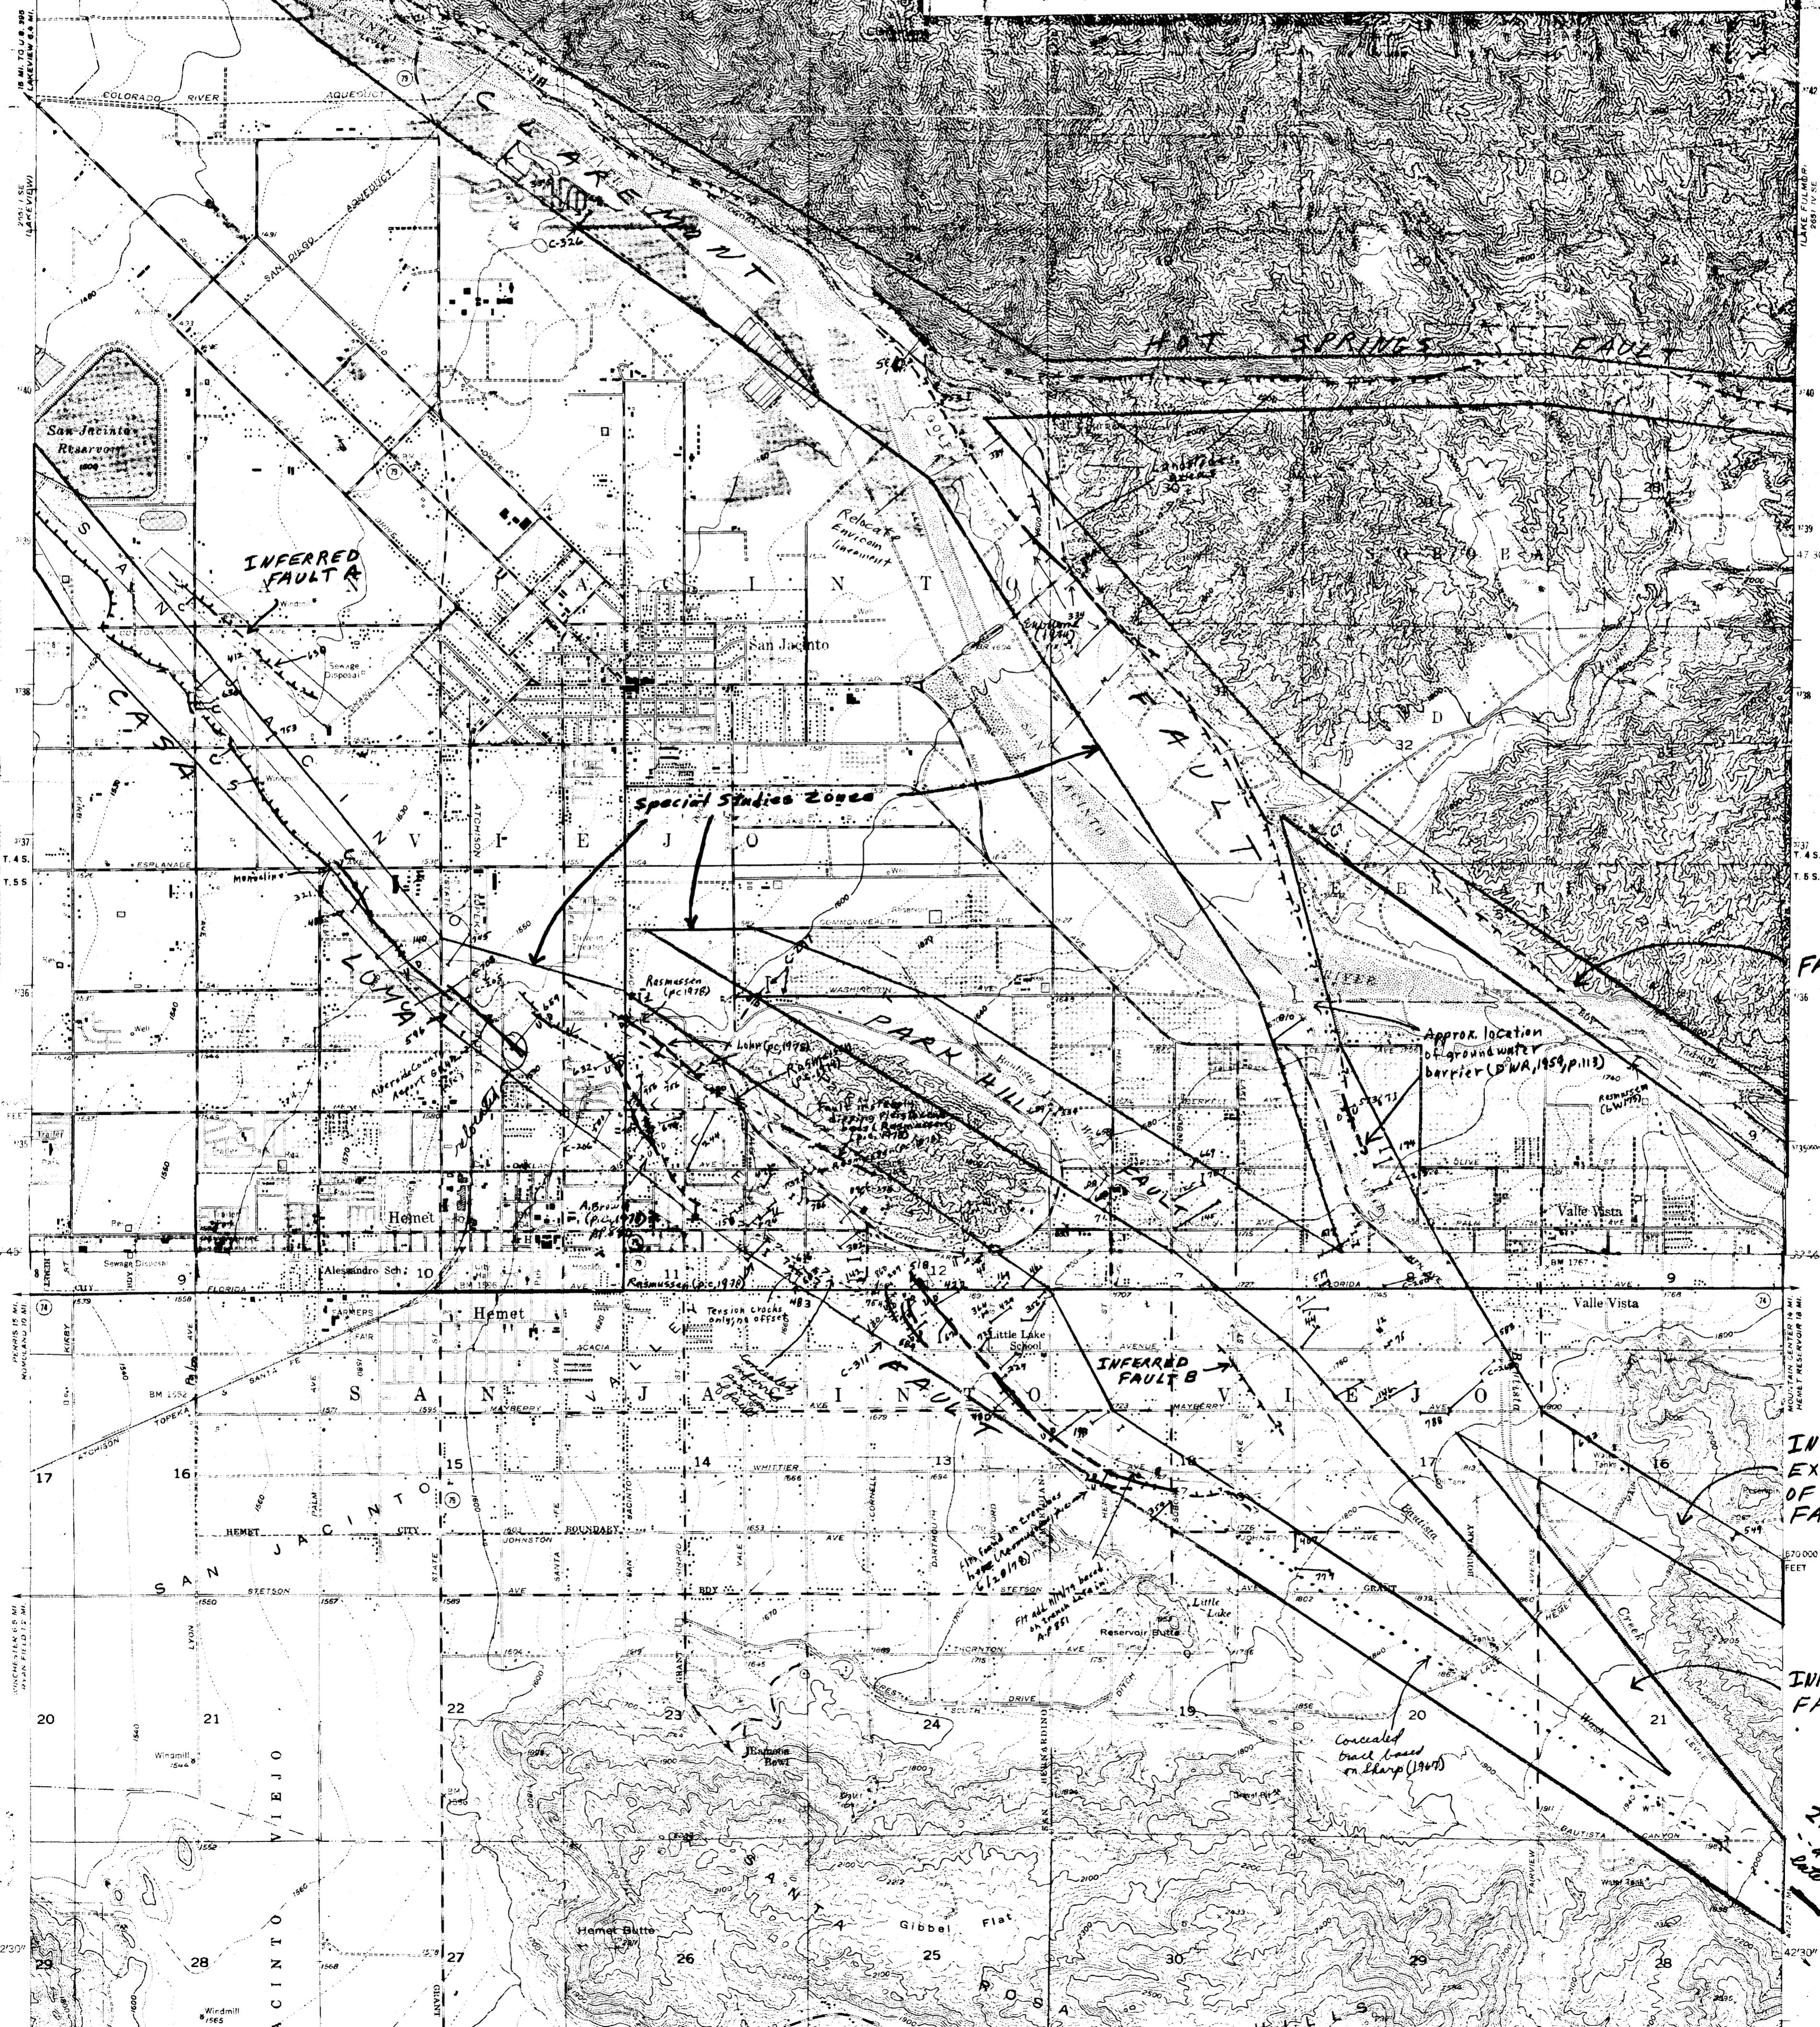
Traces of active faults based on trenching; dashed line where fault projected; trench location and source of unpublished data indicated by doubly-terminated line and number (reports are on file with COMG, Rm 1016, Ferry Bldg, SF; numbers refer to reports in A-P (e.g. 262) and informal consulting file (e.g. C-311)); large C locates areas of pavement cracked & disturbed by differential subsidence; S indicates sink holes & fissures.

Recent escarpments developed in young alluvium; presumed to be due to faulting; solid line = well-defined, dashed line = modified or subtle; hachures point down slope.

Tonal lineaments and contrasts in soil or vegetation associated with scarps and recent faults; queried where uncertain or indistinct.
